STAR BRITE

PROPERTY INSPECTION REPORT
PREPARED FOR
PETER & MARY ODELL
2613 WINTER DRIVE, PLANO, TX 75023
DECEMBER 27, 2010

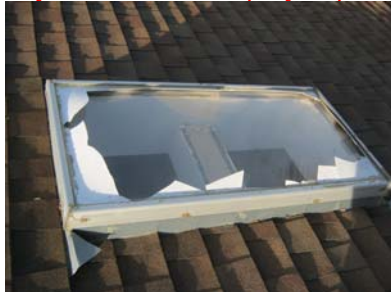
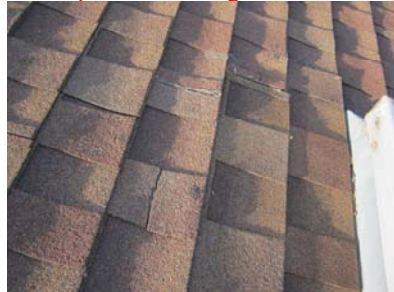
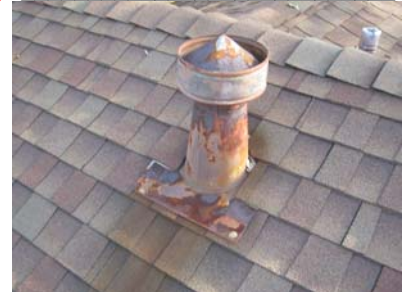
- The roof more or less is at its bottom 1/3 of its useful life. My conclusion is that the roofing material is still in reasonably good condition. There were exposed nail heads which should be patched. The flashing for the chimney was lifted. It should be screwed back down and the screw heads caulked. There was one area where some cracked shingles were poorly caulked. Recommend replacing them.
- The white plastic cover on the skylight was broken. Recommend replacement. The flue for the furnace was badly rusted and was becoming un-nailed. Recommend replacement.
- Roof valleys should be clear of any debris which will form dams which in turn will divert the water in between the shingles.
- Recommend roofing specialist to further evaluate the entire roof and recommend repairs if required. Have your insurance company inspect the roof prior to closing for insurability.

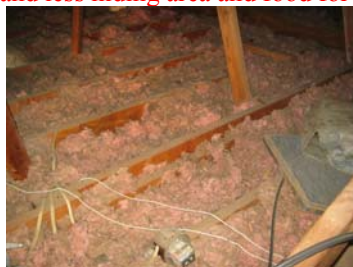
- No obvious significant roof sheathing, structural deficiencies or water stains were found from my limited viewing area of inspection. There were areas of uneven insulation coverage. Recommend smoothing out blown insulation and add extra where needed. I recommend at least another 6-“ of insulation added.
- Indoor pull down attic stairs should be insulated for better energy efficiency. All pull down attic stairs should be used with caution. Attic should be free of excessive storage items. This will keep the area safer and less hiding area and food for vermin.

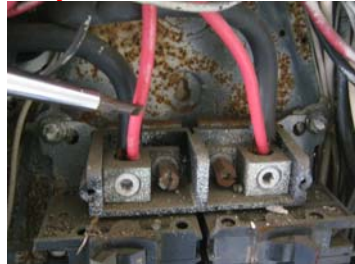
- ✳️ Main breaker panel box was overall wired in a professional manner. AFCIs were missing. They were not required at the time this house was built. Nevertheless TREC requires us to report this condition as deficient. The box was badly rusted and all the wire connections were badly oxidized. The oxidization does not allow for proper connections which may result in arcing and becoming a possible fire hazard. One reason for the oxidization may be that caustic pool chemicals were stored near the panel box. Two additional wires were inserted into the main service cable lug nuts. These lug nuts were meant to hold only one cable each. Doubling up may lead to arcing and a fire hazard. The neutral and ground wires were also doubled and tripled up. Recommend, with electrician’s advice, an upgrade and repairs to meet today’s building standards to address safety concerns.

- ✳️ Circuit breakers were not clearly and/or adequately identified in directory. Identify and mark down as soon as possible in case you have to turn off a breaker in an emergency or for repair service.

- ✳️ The panel box was of the Federal Pacific brand. There is an on-going debate about the breakers not tripping quickly when necessary. Recommend electrician to evaluate further.

- ✳️ Any deficiencies should be immediately evaluated and corrected if necessary by a qualified electrician.
